City of Bolivar, MO

Spring 1999 Fire Hydrant Testing/Coding Project

Tests conducted and report generated by:
Theron J. Becker, FPE

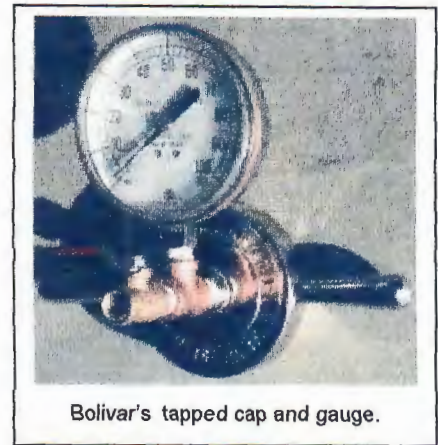
Bolivar's tapped cap and gauge.

The tapped cap and gauge is used to gather the other two data items: *static* and *residual pressure*.

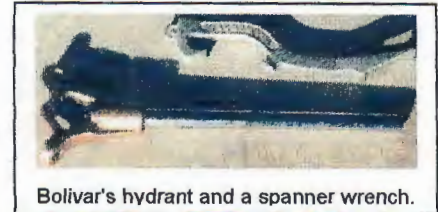
Bolivar's hydrant and a spanner wrench.

The ruler is needed to measure the actual diameter of the outlet orifice to be used together with the *velocity pressure* gained from the pitot tube to yield flow. Hydrant and spanner wrenches are obviously needed to open and close the hydrant and loosen and tighten caps and fittings.

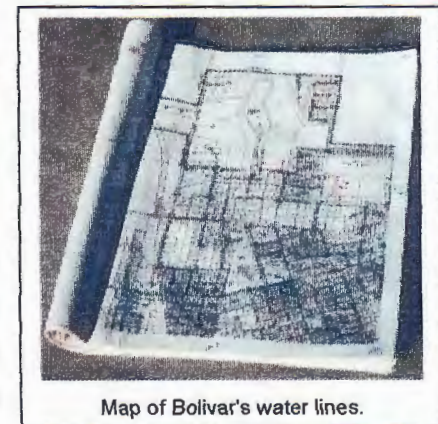
Map of Bolivar's water lines.

A water line map is essential to determine main sizes, main conditions, main types, and probable direction of water travel. Finally, a form needs to be used to record all the data gained in the field for interpretation and later use.

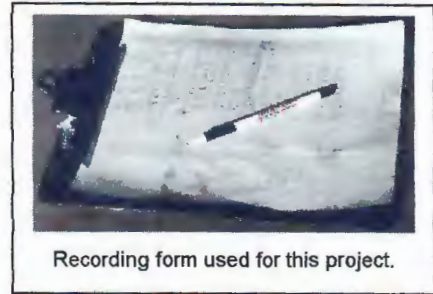
Recording form used for this project.

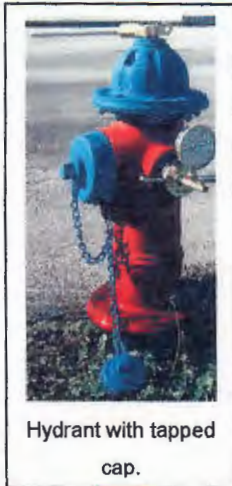
Hydrant with tapped cap.

After flushing, the hydrant can then be closed and the tapped cap with gauge can be attached to it for testing. Open the hydrant fully while counting the turns it took to open it. If the hydrant is operating correctly, it should take the same number of turns to close the hydrant. There should be no water flowing with the hydrant on, so the reading on the gauge will be the *static pressure*. Record this pressure.

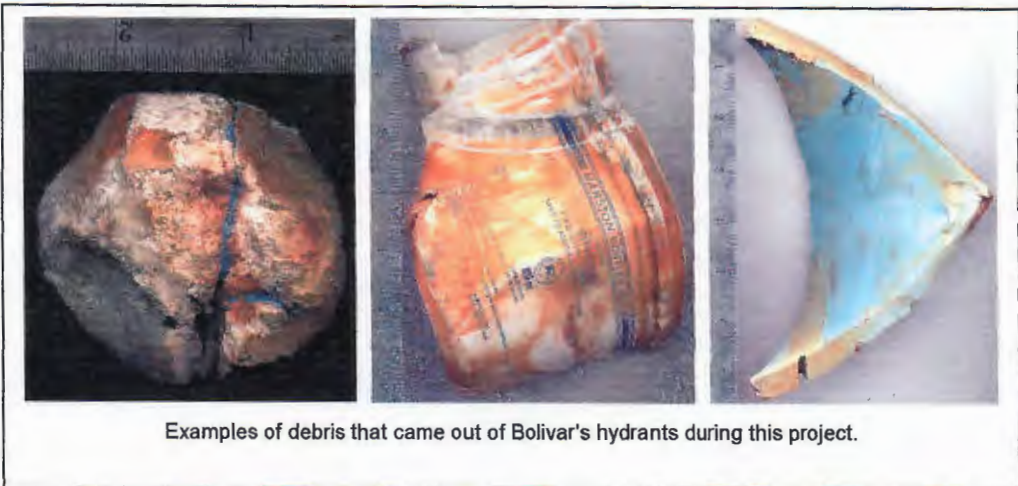
Examples of debris that came out of Bolivar's hydrants during this project.

Sometimes mains and hydrants have not been flushed for years. This allows corrosion and particulate matter to accumulate in the mains. Do not be surprised to see brown, red, black, or gray water when first opening a hydrant. Recently laid water mains often have quite a few rocks in them due to the fact that contractors rarely flush lines before attaching them to the city's system. Even small rocks can cause quite a bit of damage to instruments and fire pumps. Therefore, every hydrant should be flushed before attaching any instrument to minimize damage. Prior to opening the hydrant, one should evaluate the site and make note of which direction would be best to flow water for a few minutes to clean out the debris in the mains. Once a suitable direction is determined, remove one cap and attach any needed fittings to direct the stream, then open the hydrant enough to flush out any foul water or debris. Keep in mind that once a hydrant is opened, it may stir up rust, settled dirt, etc. in the mains for hundreds of feet. Before finishing testing in an area, the mains need to be

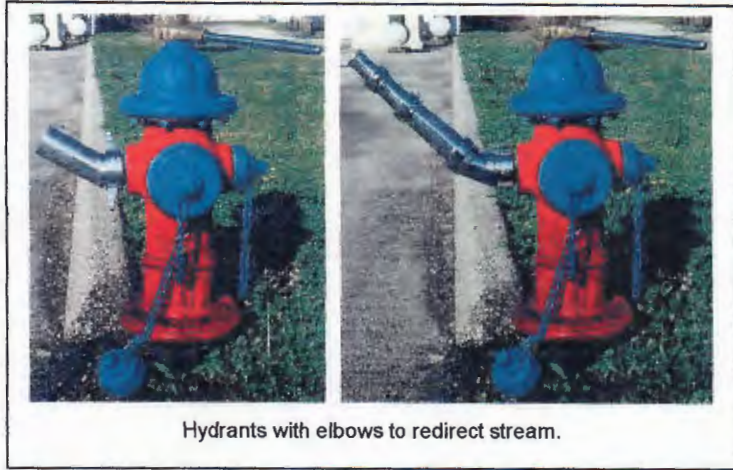
Hydrants with elbows to redirect stream.

erosion, or traffic conditions pose a problem. The problem with using this elbow is the basic equation used to transform pitot pressures into gallons per minute requires the use of a specific mathematical coefficient depending on the outlet. There is no factor for an elbow. Therefore, in conjunction with an elbow, a straight stream nozzle must be used. As in this project's case, a diffuser can be used in lieu of the elbow and nozzle.

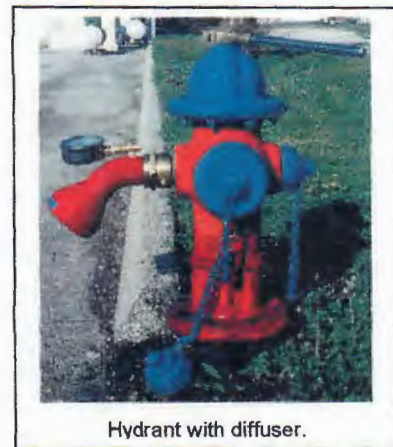
Hydrant with diffuser.

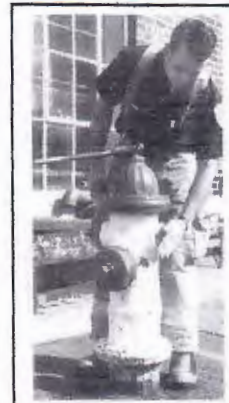
Example of testing a hydrant's draining ability. (Hall 387)

Remember to close each hydrant slowly to reduce the chance of damaging equipment or lines by causing a *water hammer*. Also, after closing a hydrant, the water should drain from drain holes under the ground to prevent it from freezing in the hydrant. To check the hydrant to verify it is draining properly, simply cover the opening(s) with your hand(s). You should be able to feel a slight suction or hear air escaping into the hydrant when you pull your hand(s) away.
